## Mandatory Action Jan. 2017

Inspection of the Horizontal Stabilizer tail attachment brackets

All CH (Chris Heintz designs) series of aircraft. This includes the Zodiac and STOL models.

Transportation Safety Board of Canada - **AVIATION SAFETY ADVISORY A1600137-D1-A1**  
**Zenair Zodiac CH-601A—Risk of structural failure of the horizontal stabilizer**

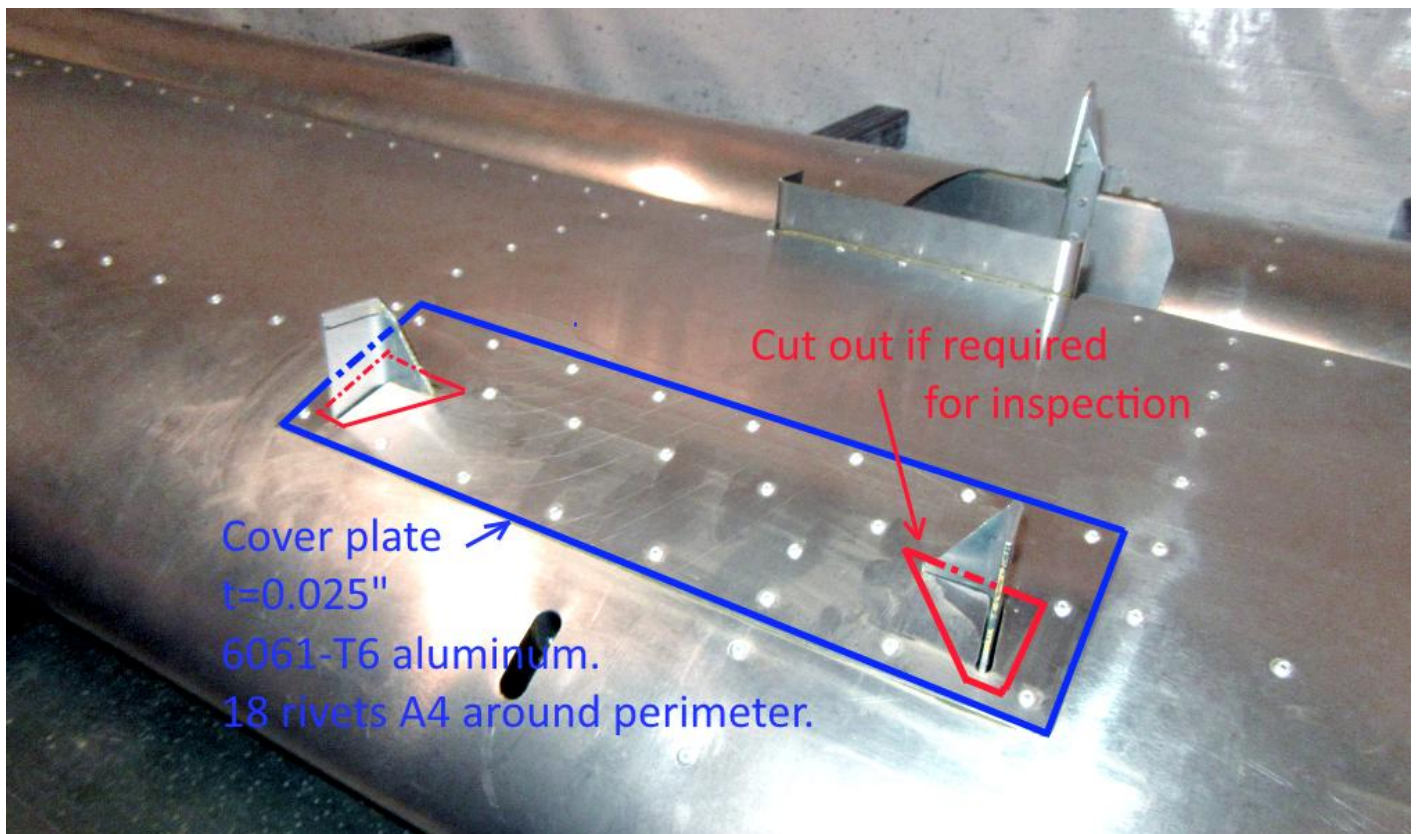
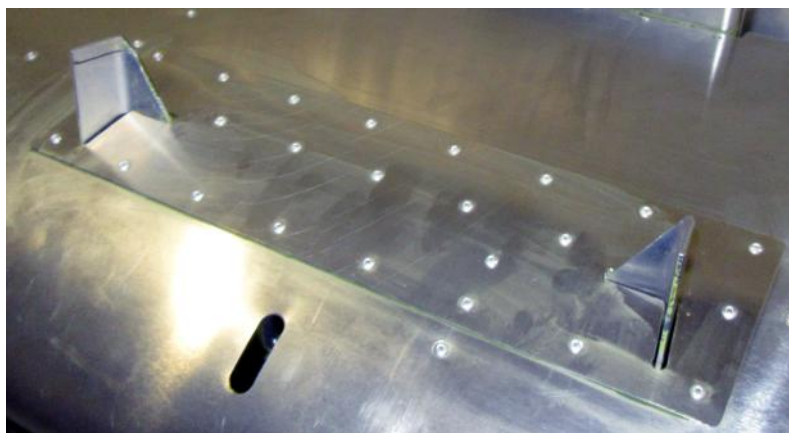
If you are not able to properly inspect inside the H.S. forward attachment brackets and associated rivets, cut out the area as shown in the following sketch. Add a cover plate after inspection as shown. Fasten into place with 18 rivets A4 around the perimeter of the cover plate.

If the brackets are to be replaced, the cut out holes can be made larger. See FAA AC-43-13-1B section 4-32, Figure 4-16 when adding a covering.

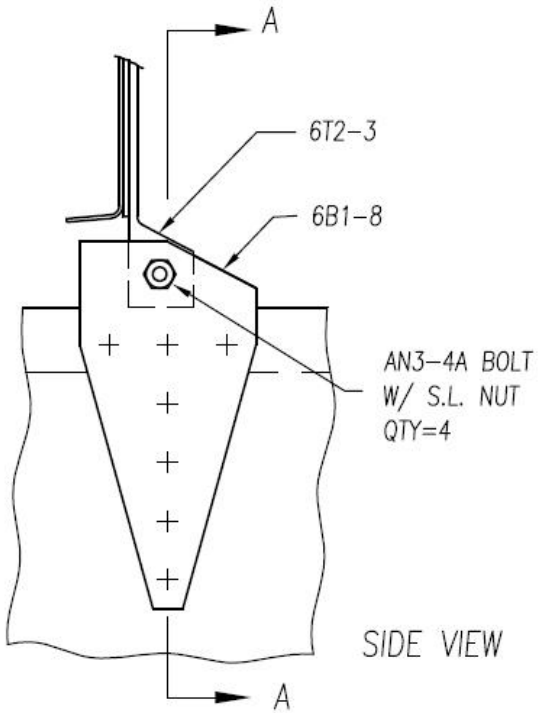
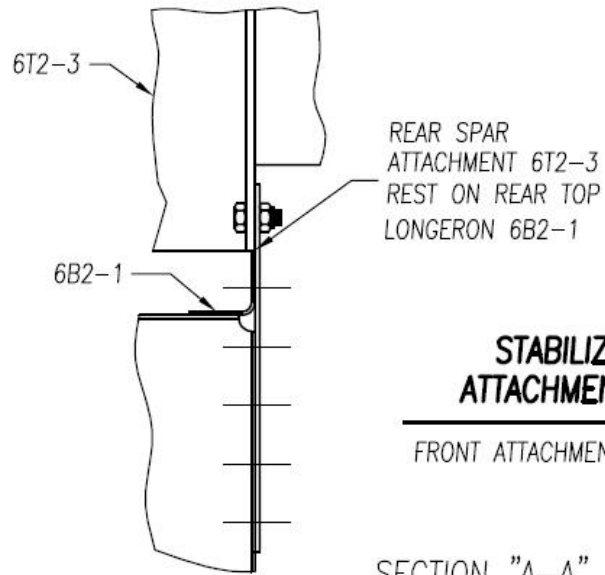
Gap between the fuselage fitting and H.T.  
is not acceptable. Parts will be stressed when bolted  
resulting in possible cracking.

Replace parts that do not match the aircraft airframe blueprints (drawings). Replace parts that have been drilled or assembled incorrectly. The H.S. must fit snug to the fuselage fittings. Bolts when tight must not bend the H.S. fittings. Correct type rivets must be installed properly as per the design standards manual. If you did not assemble your airframe, hire a certified aircraft mechanic to complete this task. Log book entry must be made. When reinstalling, use new AN bolts and self locking bolts. Torque them as per AC 43-13 1B and 2B. Do not over tighten the bolts. Once installed, check control cable tensions, all connections, interferences, etc. See [http://www.newplane.com/Service\\_Letters\\_Bulletines/Control%20cable%20tensions%20Zodiac.pdf](http://www.newplane.com/Service_Letters_Bulletines/Control%20cable%20tensions%20Zodiac.pdf) including all other continued airworthiness documentation and make sure your aircraft is up-to-date before flying. When the aircraft is parked outside, lock the control cables. Strong winds can cause significant damage to the control system.

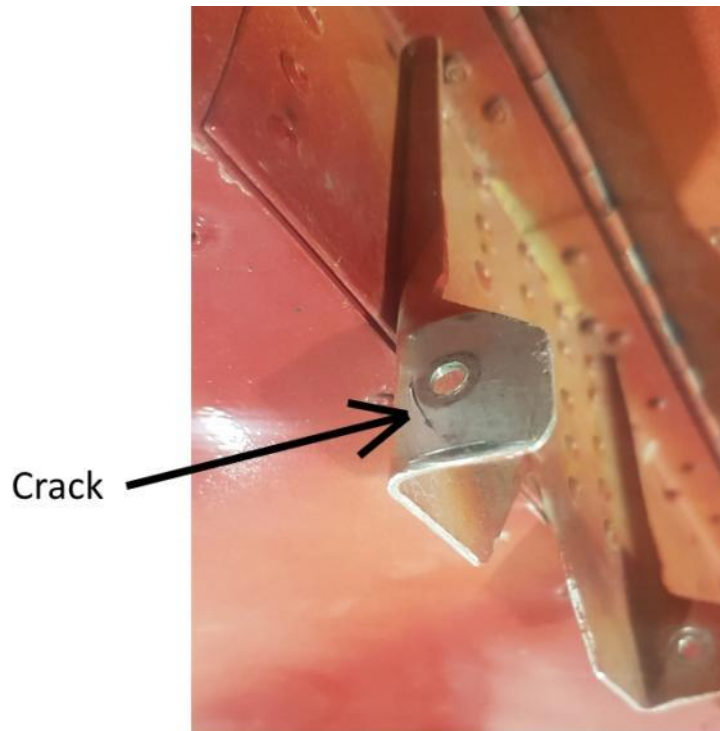
View of H.S. rear attachment bracket. A crack is developing in the part. Part must be replaced.

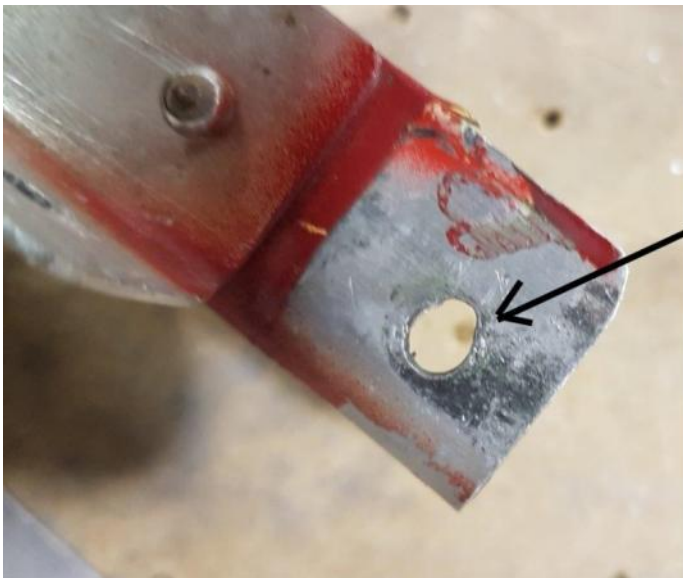
Strange hole.  
Part must be changed.

View of H.S. front attachment bracket. Bolt hole was not properly drilled. Part must be replaced.

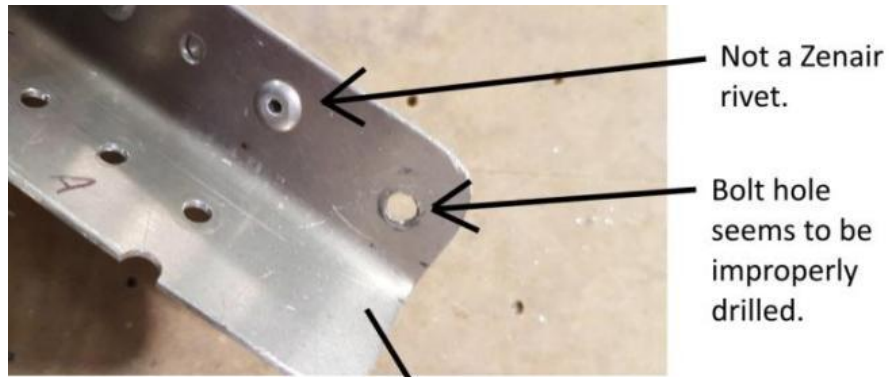
Bracket attaching horizontal stabilizer to fuselage.  
This is not an original bracket.

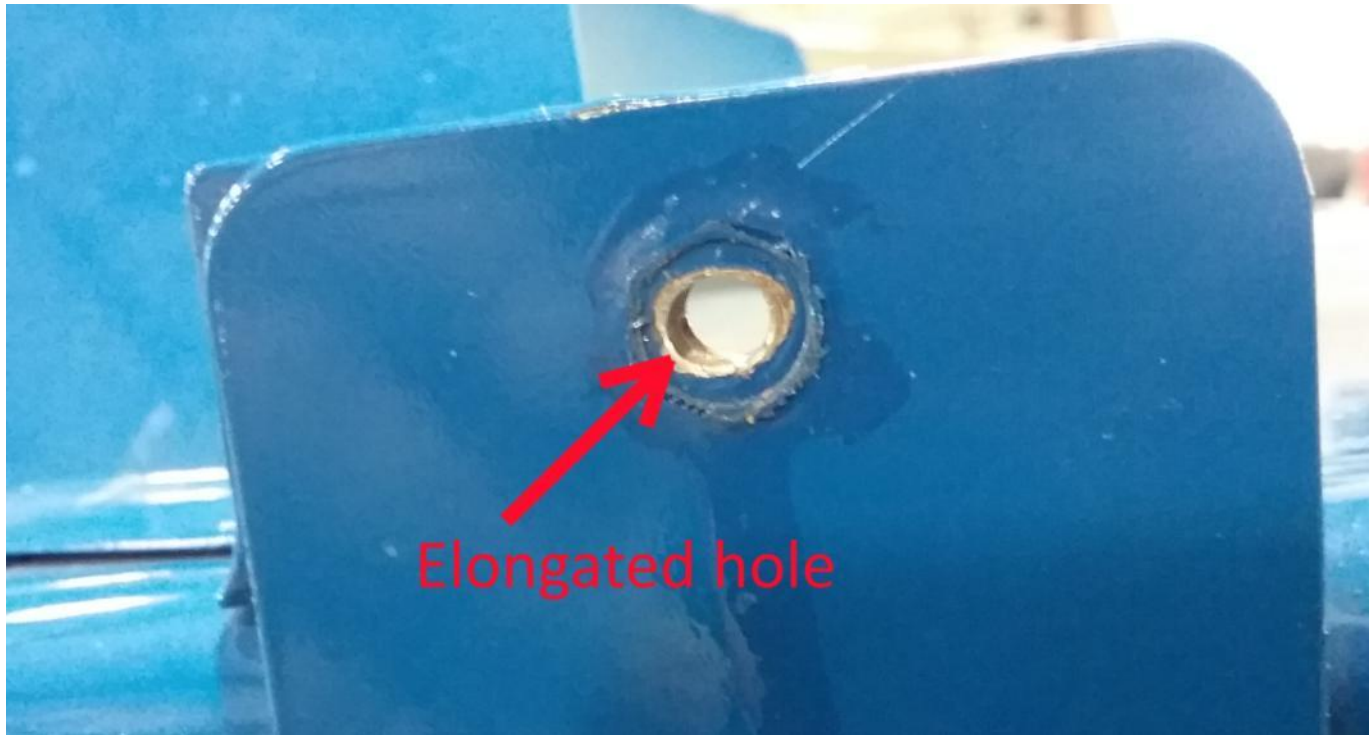
Above part must be replaced. The two above photos are from the same aircraft. It is possible that due to an elongated hole, the stabilator bracket cracked as the bolt was moving in the hole.

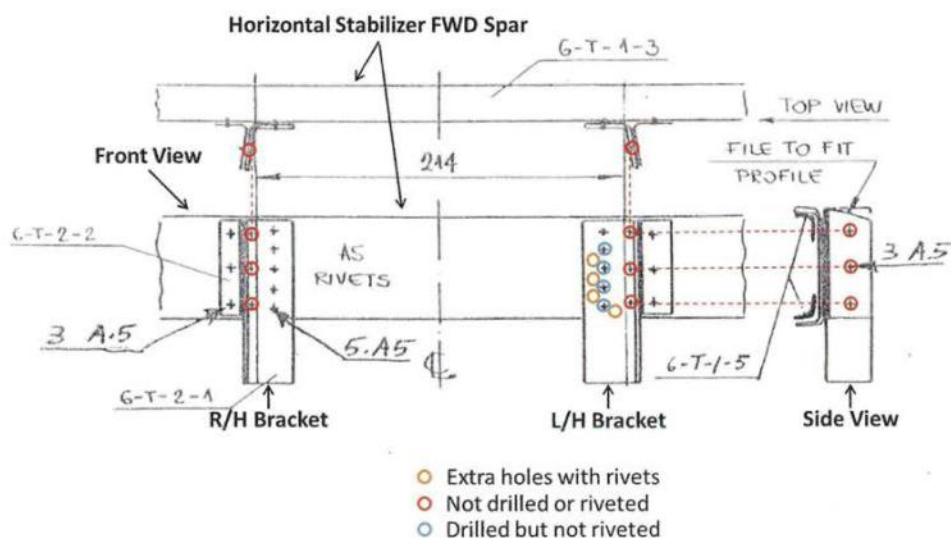
**Figure 1.** Horizontal stabilizer forward structural attachment—aircraft drawing. (source: Zenair, with digital annotations by the TSB)

As per the drawing (Figure 1), the horizontal stabilizer forward structural attachment is designed to be constructed by riveting two aluminium angles (attachment bracket 6-T-2-1 and attachment doubler 6-T-2-2) with three rivets back-to-back and connecting the attachment bracket to the front surface of the forward spar (6-T-1-3) with five rivets.

In the actual installation, the three rivets connecting each attachment bracket to the associated attachment doubler were missing and the required holes were not drilled. Four additional holes were drilled through the left attachment bracket and continued through the forward spar. Rivets were installed in all of these additional holes; however, they were only installed in one of the five holes specified in the drawing.

Structural integrity of the horizontal stabilizer forward attachment point was compromised on both sides because of the missing rivets, and the strength of the forward spar itself was reduced because of the extra holes.
