STOL CH 801 CONTROLS

SECTION 3 Control Stick Ref Dwg 8CF-3

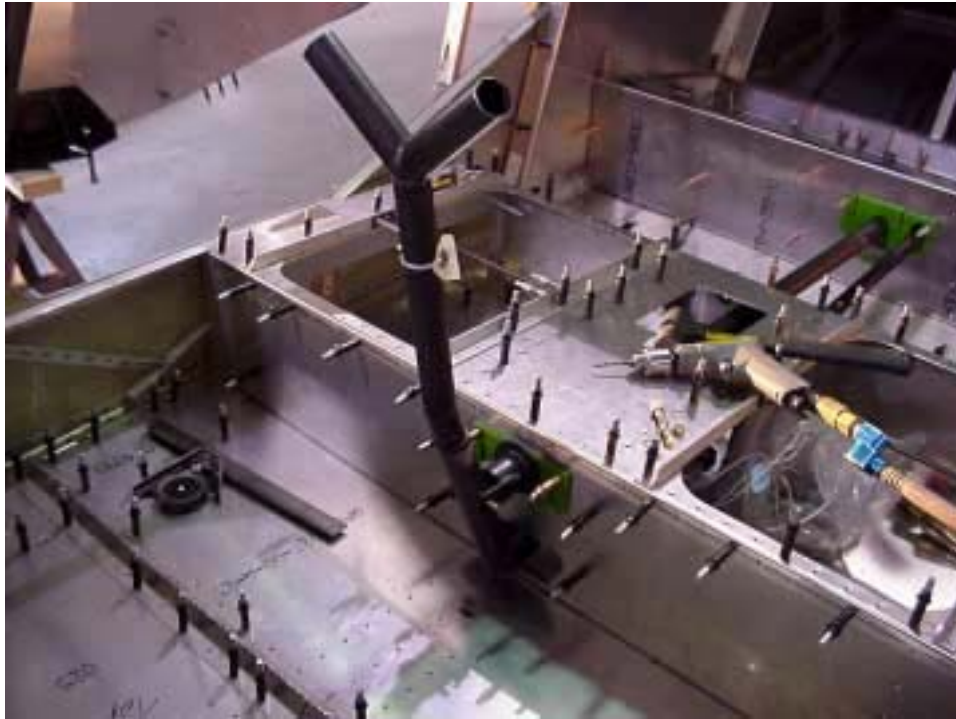
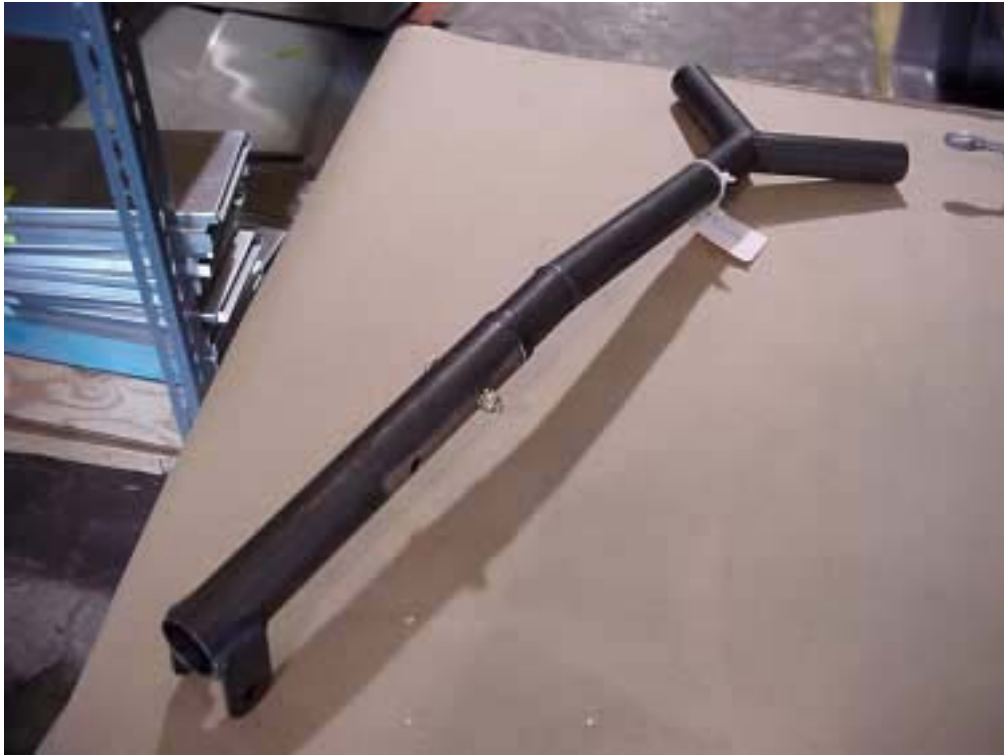
**CONTROL STICK
8C8-1A**

**CONTROL STICK
UPPER
8C8-1C**

**AIRFRAME BOLT & SL
NUT
AN3-15A**

Drill the 3/16" hole 25mm
from the top of the Stick
8C8-1A

Slide the Control Stick Upper 8C8-1C into the top of the Control Stick 8C8-1, let it bottom out on the stop ring welded on 8C8-1C (check: 60mm from the bottom of the upper stick 8C8-1C to the bottom of the stop ring). Position the stick assembly as shown in the photo (the top of 8C8-1A does not touch the workbench). The 3/16" hole is drilled parallel (horizontally) to the workbench.

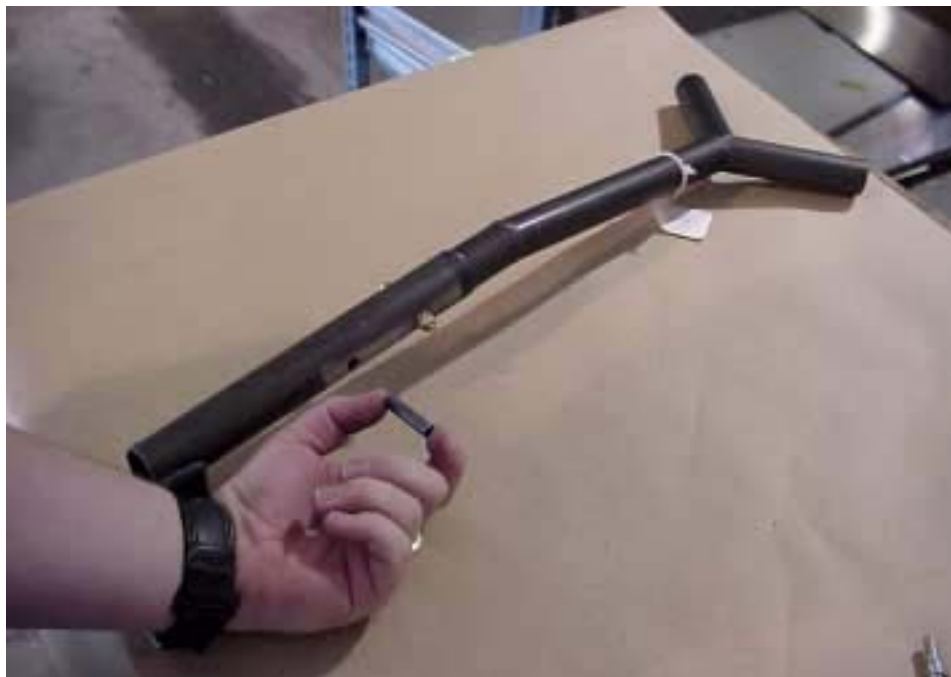
**CONTROL STICK
BUSHING
8C8-1B**

Lubrication: Clean
inside the tube welded on
the stick 8C8-1C Add
some lubrication inside
the tube, then slide the
bushing 8C8-1B inside
the tube.

The Bushing fits inside Control Stick 8C8-1A

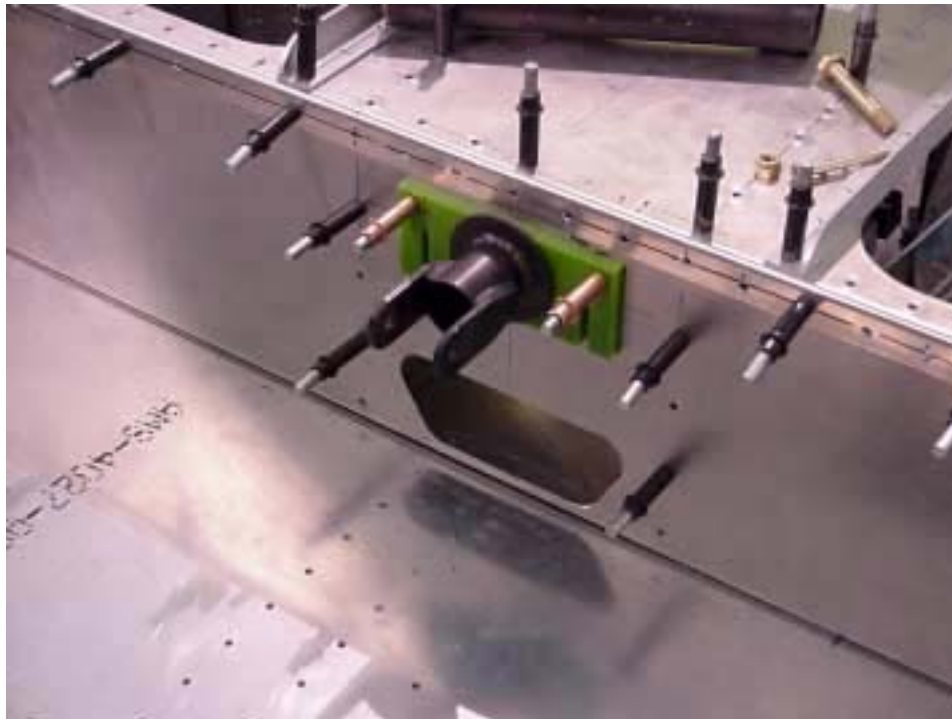
**Forward torque tube
8C8-2**

CHECK: The bushing 8C8-1B fits in between the two plates welded on the sides of the torque tube 8C8-2

Refer to drawing 8FF-2 for the cutout in the Front Seat Panel 8F11-1

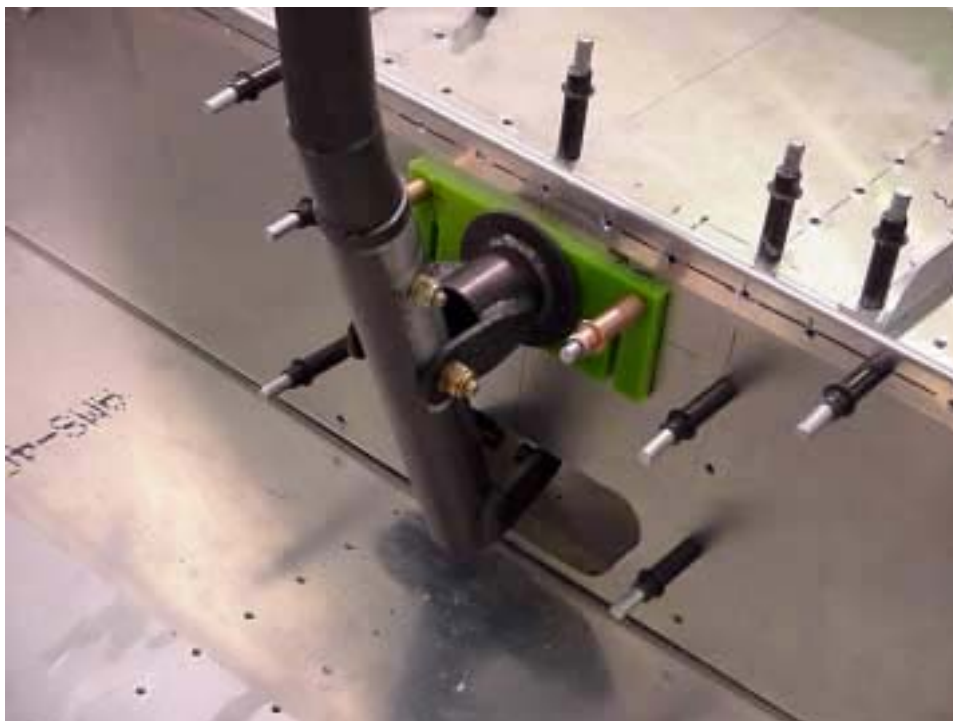
**AIRFRAME BOLT & SL
NUT + 2 WASHERS
AN4-20A**

Note: The bolt clamp down on the bushing (the bushing does not turn). The Bearing surface is between the outer wall of the bushing 8C8-1B and the inner wall of the welded tube on 8C8-1A

CHECK: That the bottom of the control stick does not interfere with the rivets in the floor skin.

2 washers: One washer under the head the other under the nut.

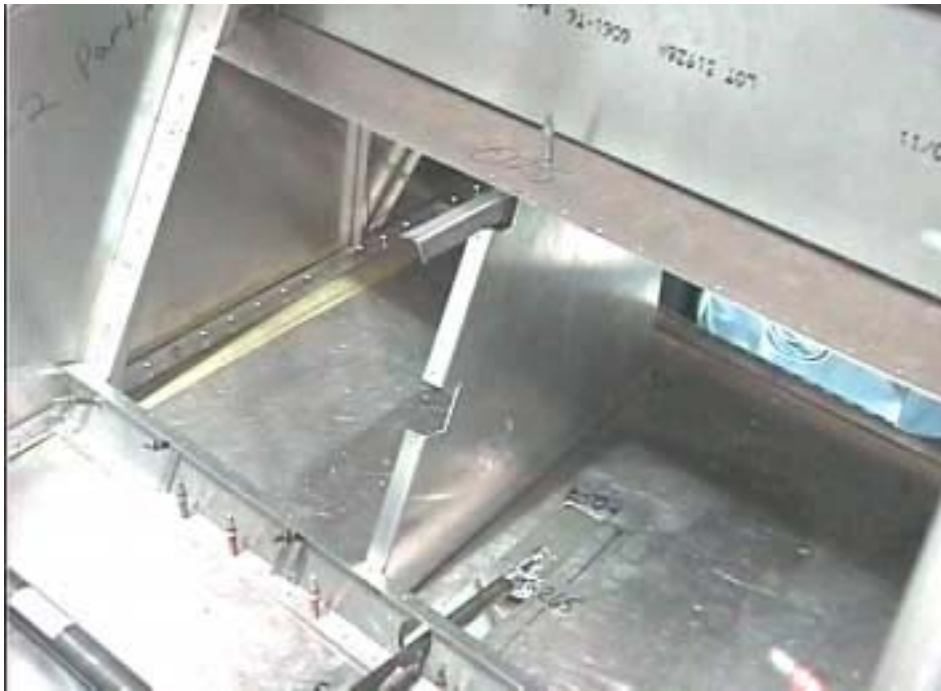
Location of the cutout in the bottom skin between the left and right Horizontal Tail Support Channels 8C1-2

Cutout in the rear fuselage bottom skin to make room for the aft end of the Elevator control Rod 8C8-16

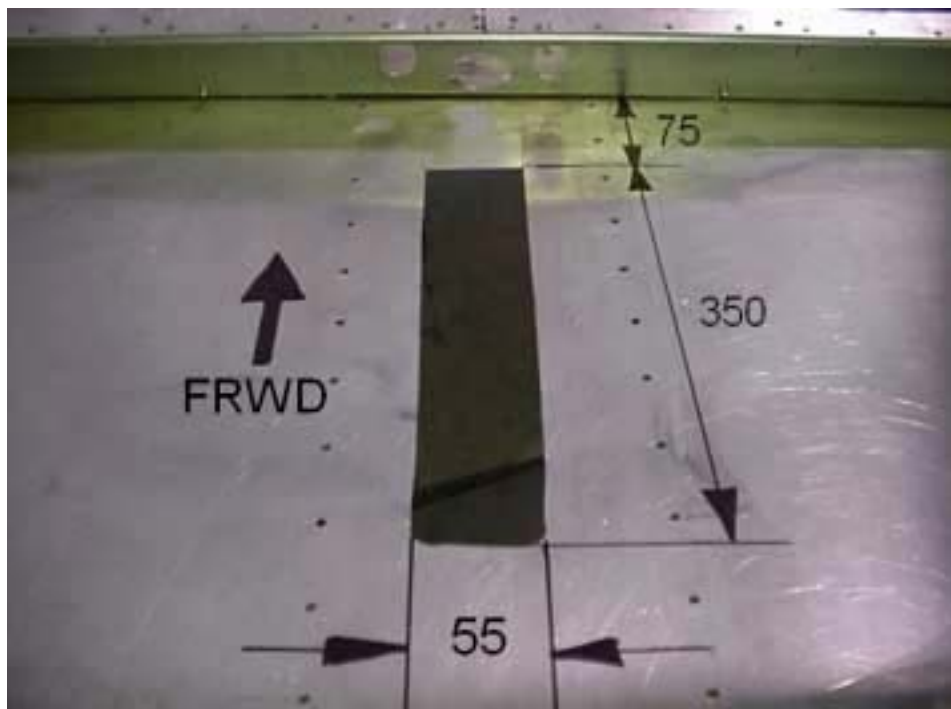
Cutout in the Fuselage Bottom Skin 8F2-3A (centered on the aircraft center line)

Cutout: 55x350mm

If you haven't already done so, remove the rear seat back panel and layout the clearance hole for the elevator control rod and bell crank on the bottom skin.

Cut the hole to size; note the radius at all four corners of the hole. The forward edge of the hole is 75mm aft of the rear seat support channel 8F11-8.

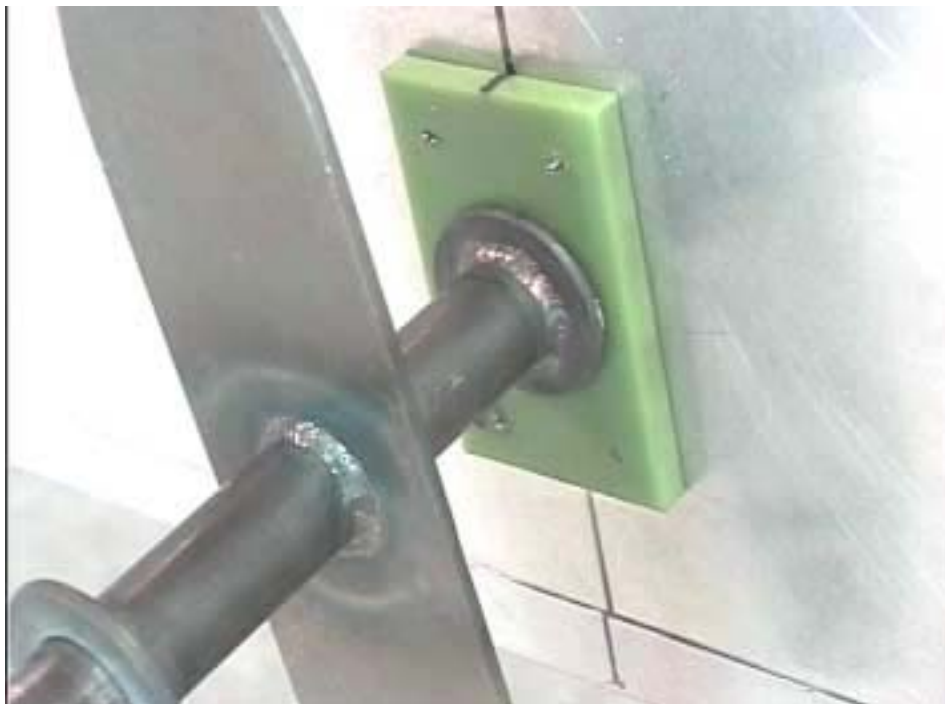
**HORIZONTAL TAIL
BELLCRANK
8C1-3**

**HORIZONTAL TAIL
BEARING
8C1-3**

Open the hole in the
aluminum an additional
2 - 3mm then rivet the
bearings in place.

Drill the center hole in 8C1-2 to $\frac{3}{4}$ inch diameter.
Fit the bearing 8C1-3 on the inboard side of 8C1-2 and drill four, $\frac{3}{16}$ holes
in each.

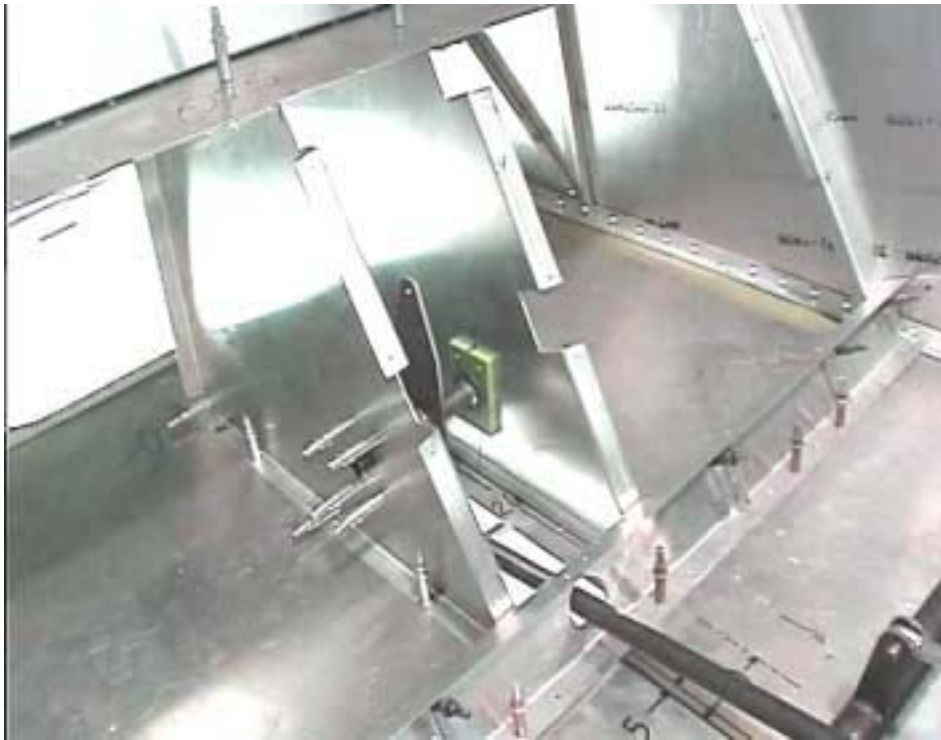
Rivet the Bearing 8C1-3
to the Support 8C1-2

4 RIVETS A6

Re-install the Supports and the Bellcrank to the fuselage.

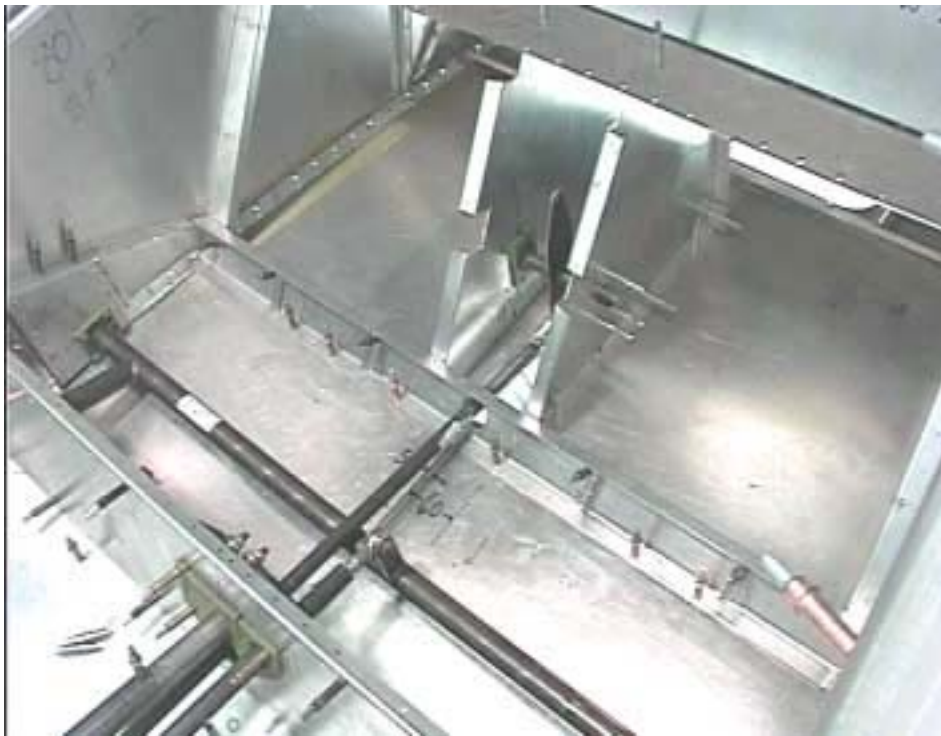
CHECK: That the
underside of the elevator
Control Rod 8C8-16 does
not touch the top of the
Flap Torque Tube 8C8-5
(Rotate the Bellcrank to
check the clearance at
the low point of the
swing).

Airframe bolt
AN5-12A

Attach the elevator push rod to the bottom of the Bellcrank. Work the stick and check all areas along length for any interference and for freedom of movement.

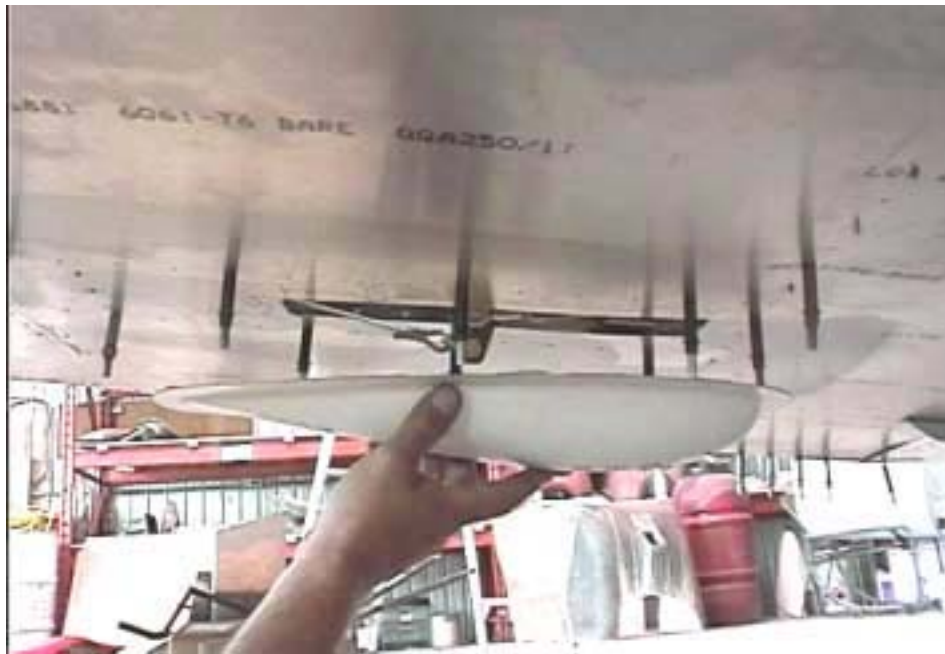
**FIBERGLASS BELLY
CHEEK
8-BC**

Fit the belly cheek 8B-C but do not rivet. Forward position in this illustration is to the right side of the photo.
