STOL CH 801 CONTROLS

SECTION 4 Horizontal Control Rods Ref Dwg 8CF-4

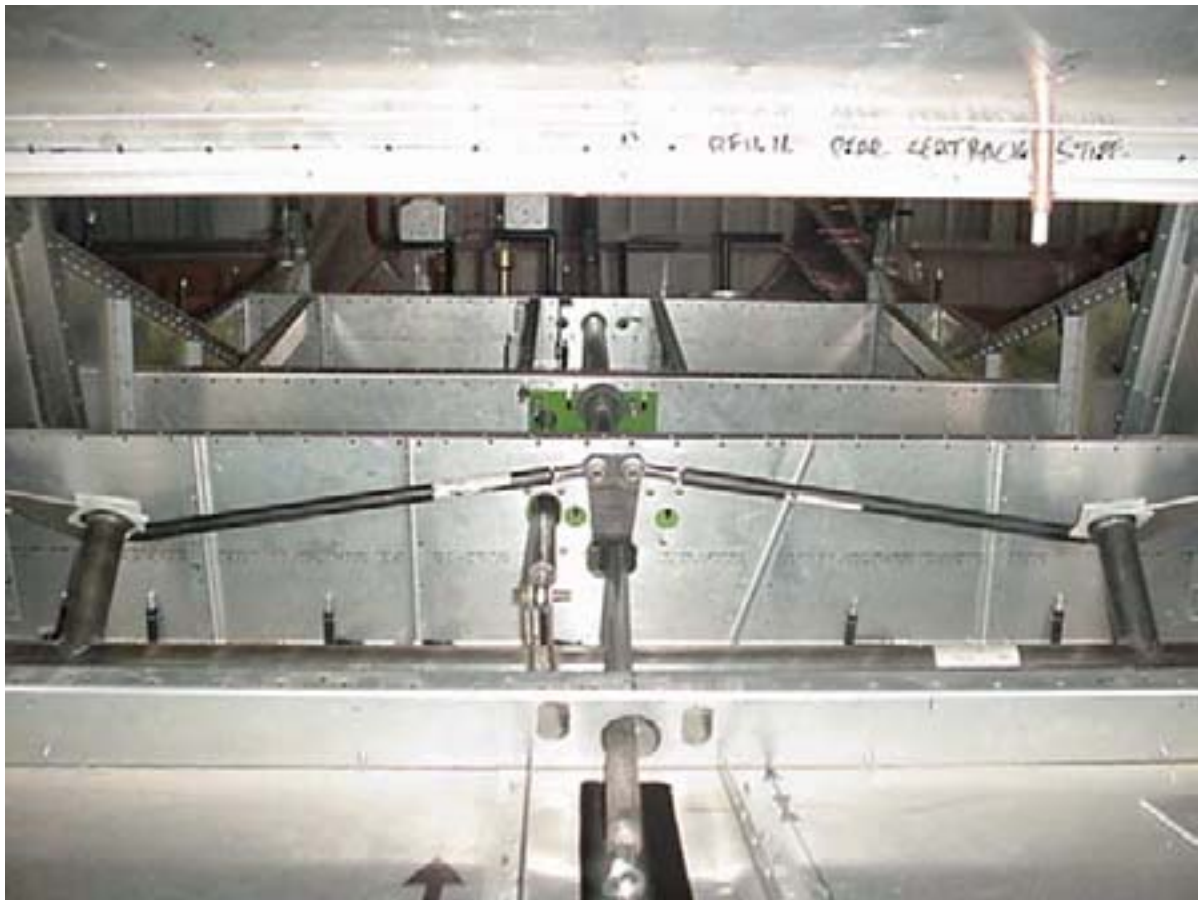
Rear seat back and seat bottom removed. Photo taken from the rear fuselage access hole looking forwards at the Horizontal Control Rods 8C9-1

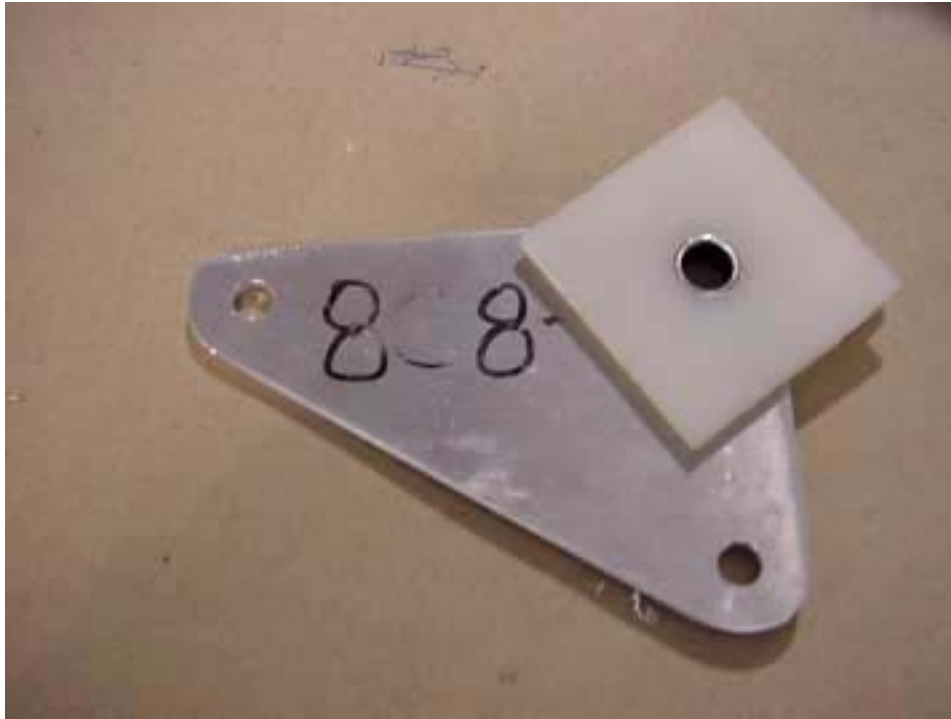
Insert the bushing and a 1/8" Bearing on each side of the Bellcrank.

CHECK: The bushing turns freely in the 1/2" hole

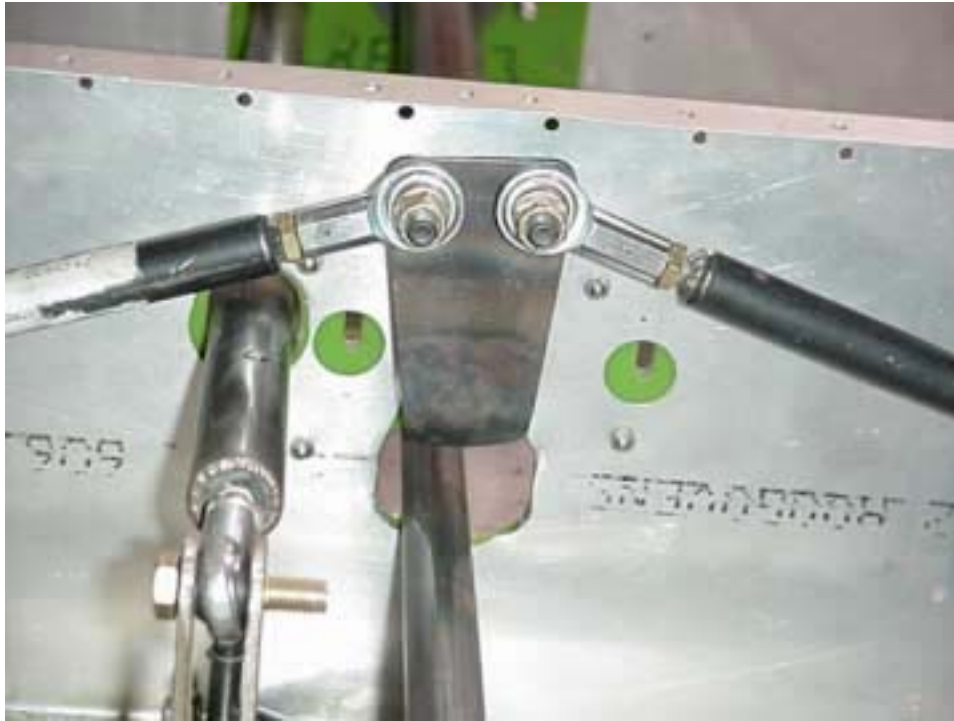
**FLAPERON
HORIZONTAL CONTROL
ROD 8C9-1**

**JAM NUT
AN316-5R**

**ROD END
CW-5-12**

CHECK: The threaded rod should be visible in the inspection hole drilled in the side of the Rod end.

Screw the Jam nut and rod end to the end of the Control rod. Set the distance between the bolt center of the rod end, see top left diagram on drawing 8CF-4

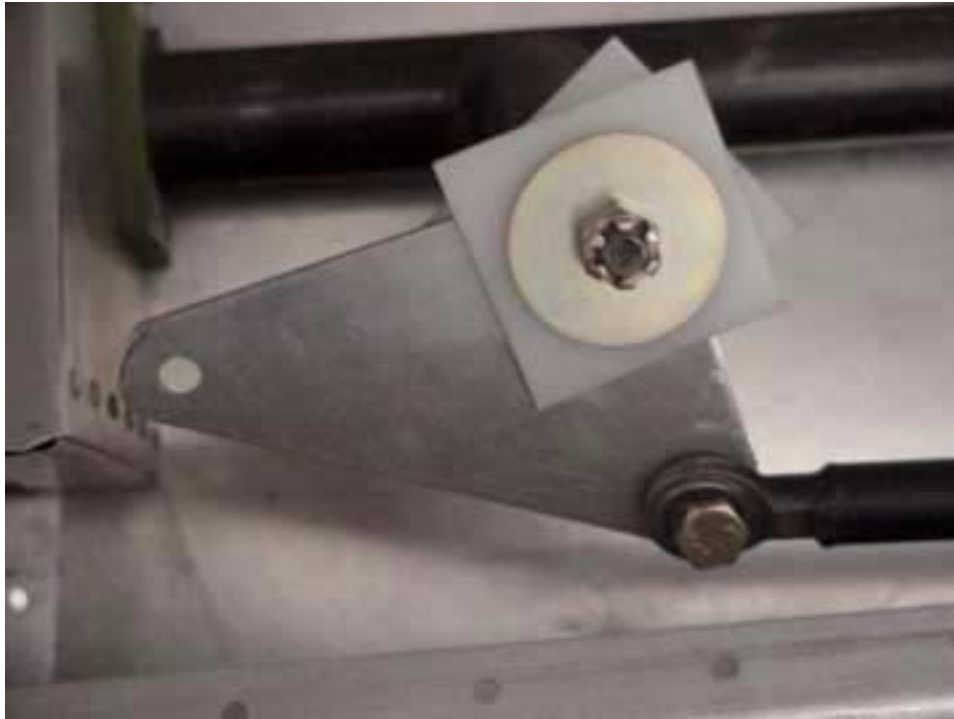
**AIRFRAME BOLT
AN5-10A WITH SL NUT**

Bolt the O/B end of the rod on the front side of the Bellcrank.

Detail of right side, the long leg of the Bellcrank is towards the top pointing O/B

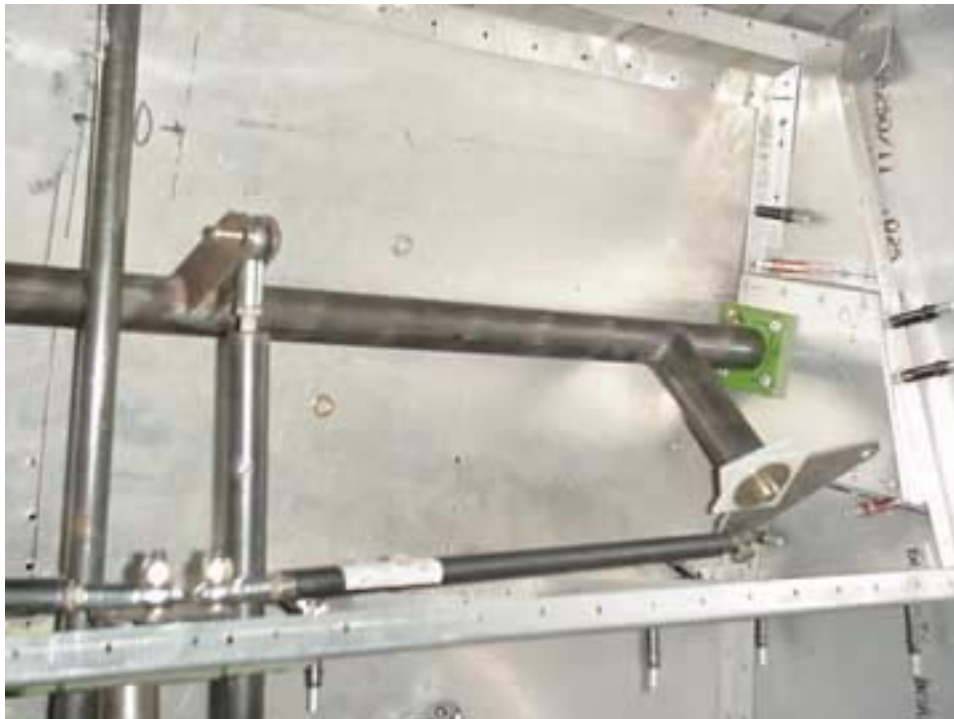
Detail of right side.

Rods connect the Bellcrank to the Rear torque tube.
