## STOL CH 801 WING ASSEMBLY

# "INSTALLING THE BOTTOM SECTION OF THE LEADING EDGE SKIN"

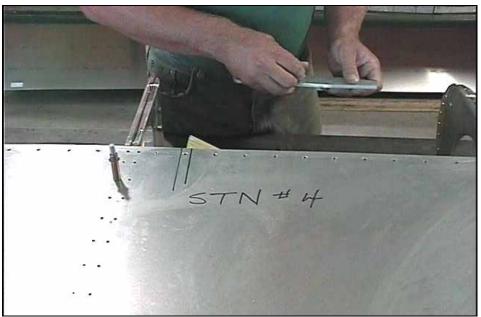
file V-80 Photo V7-1

Remove the strut attach bracket from the spar.

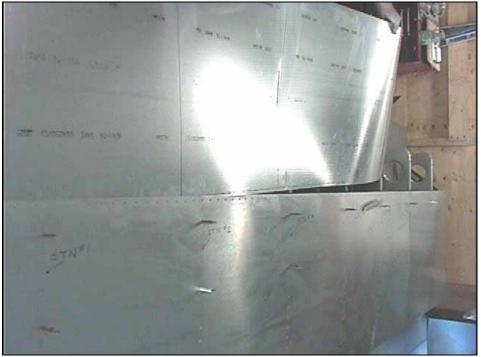
file V-81 Photo V7-2

The leading edge skin consist of two pieces 8V7-1 O/B and 8V7-1 I/B.

The skin 8V7-1 I/B is the largest and is installed first.

The location of the precut slots for the slat attachment brackets is the best indicator in determining which skin is for the left or right wing.

Install the leading edge skin.

This skin fits under the rear skins at this time to facilitate transferring the rivet holes from the predrilled holes in the rear skin.

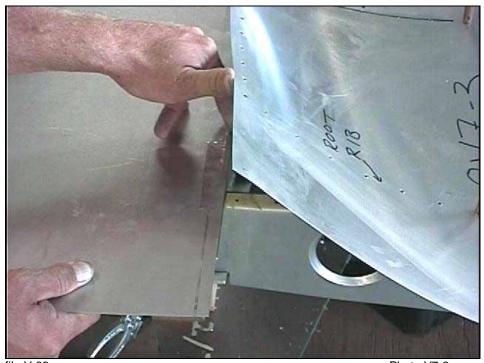
file V-83 Photo V7-3

The leading edge skin goes under the rear skin and flush with the rear edge of the spar cap. Lateral position is established by aligning the predrilled holes with the rib centerline.

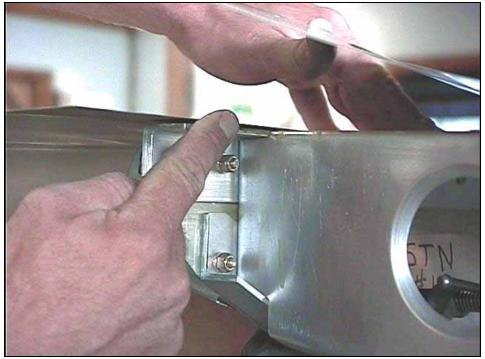
file V-86 Photo V7-5

Nose skin is flush with rear of spar cap.

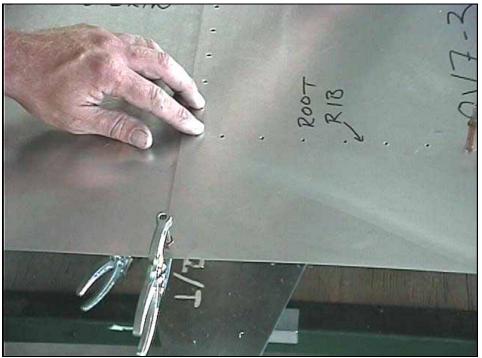
file V-84 Photo V7-7

The edge of the skins are to be flush with each other. Clamp securely.

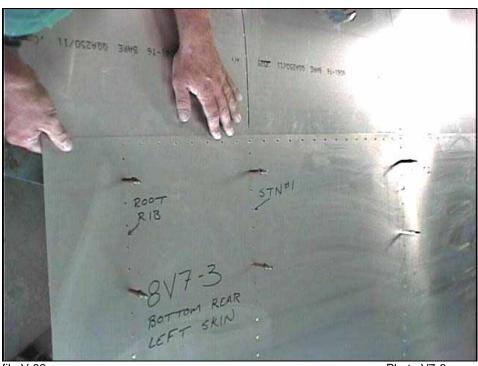
Photo V7-8

Take your time to establish the proper alignment.

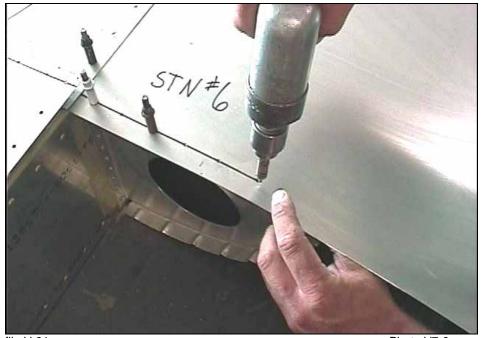
file V-91 Photo V7-9

When drilling the rib rivet holes, drill only the holes on the bottom rib flanges.

Proceed to drill the rib rivet holes. - Align each rib center line, drill, cleco -3/32 drill.

Where the rear skin was installed every 8<sup>th</sup> to 10<sup>th</sup> hole was drilled in the main spar. Drill these same holes through the leading edge skin and re cleco.

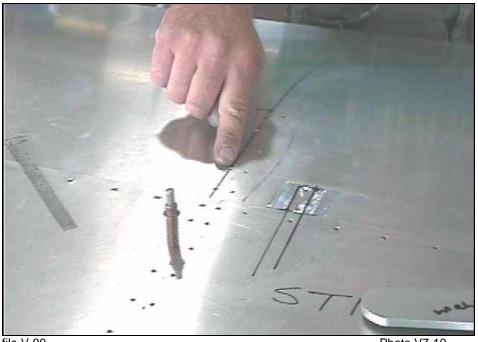
file V-90 Photo V7-10

Disregard the double run of rivet holes shown in this photo.

Second row is drilled in assembly instruction section 8.

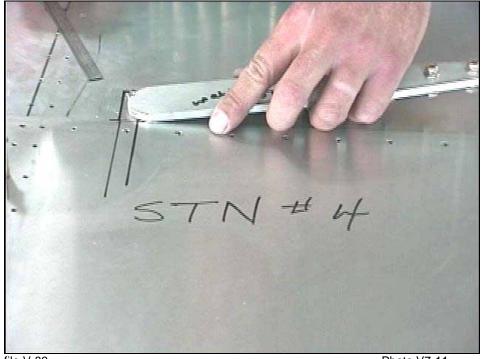
file V-89 Photo V7-11

At station #4, (photo V6-9) extend the lines you made earlier for the main strut attachment clearance hole onto the leading edge skin.

The strut attachment runs through this area.

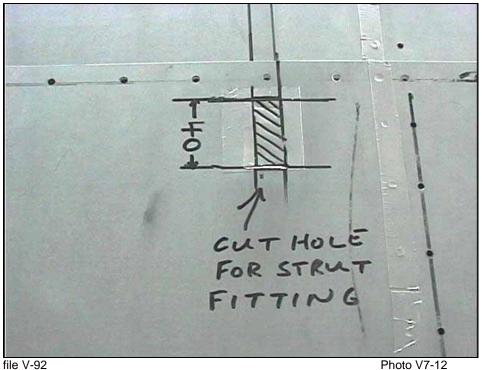
Strut attachment clearance hole layout.

Drill out the corners of the hole, cut and file to size. The edge of the hole closest to the main spar is flush with the forward edge of the spar.

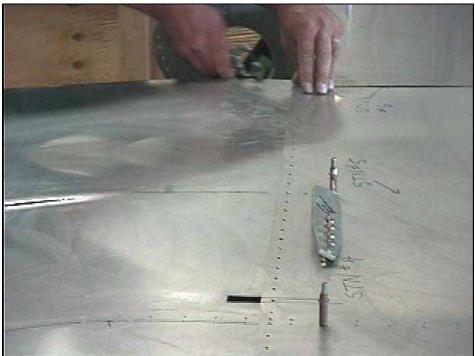
file V-85 Photo V7-13

Cleco the leading edge skin back in position with the hole cut for the main strut attach bracket. Test fit bracket to be sure of correct clearance. But don't install it permanently yet.
