## Mandatory Action Jan. 2017

Inspection of the Horizontal Stabilizer tail attachment brackets

All CH (Chris Heintz designs) series of aircraft. This includes the Zodiac and STOL models.

Transportation Safety Board of Canada - **AVIATION SAFETY ADVISORY A1600137-D1-A1**  
**Zenair Zodiac CH-601A—Risk of structural failure of the horizontal stabilizer**

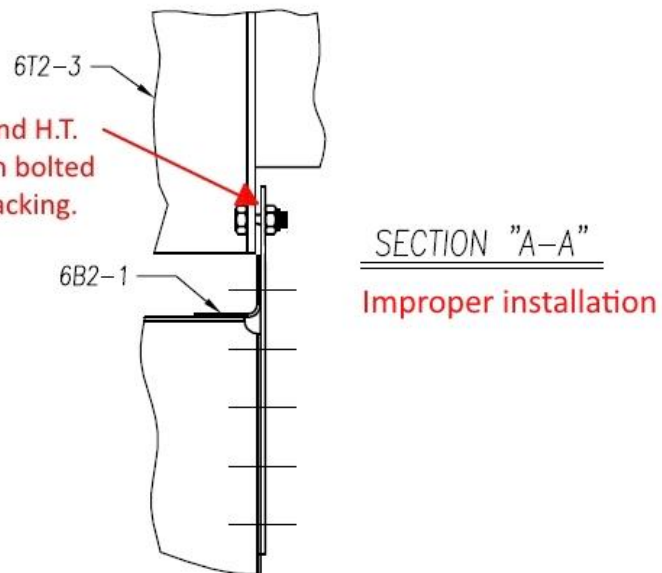
Gap between the fuselage fitting and H.T.  
is not acceptable. Parts will be stressed when bolted  
resulting in possible cracking.

Above assembly drawing is for a typical CH 601 aircraft. Each CH design is different. Use your airframe model blueprints (drawings) and not the above example for inspection and installation.
